February 25, 2011

Waste Management of Hawaii
Waimanalo Gulch Sanitary Landfill
92-460 Farrington Highway
Kapolei, Hawai'i 96707

Subject: Liner Damage Assessment, Repair, and Construction Quality Assurance Report
for Cell E6 Sideslope, Waimanalo Gulch Sanitary Landfill, Kapolei, HI

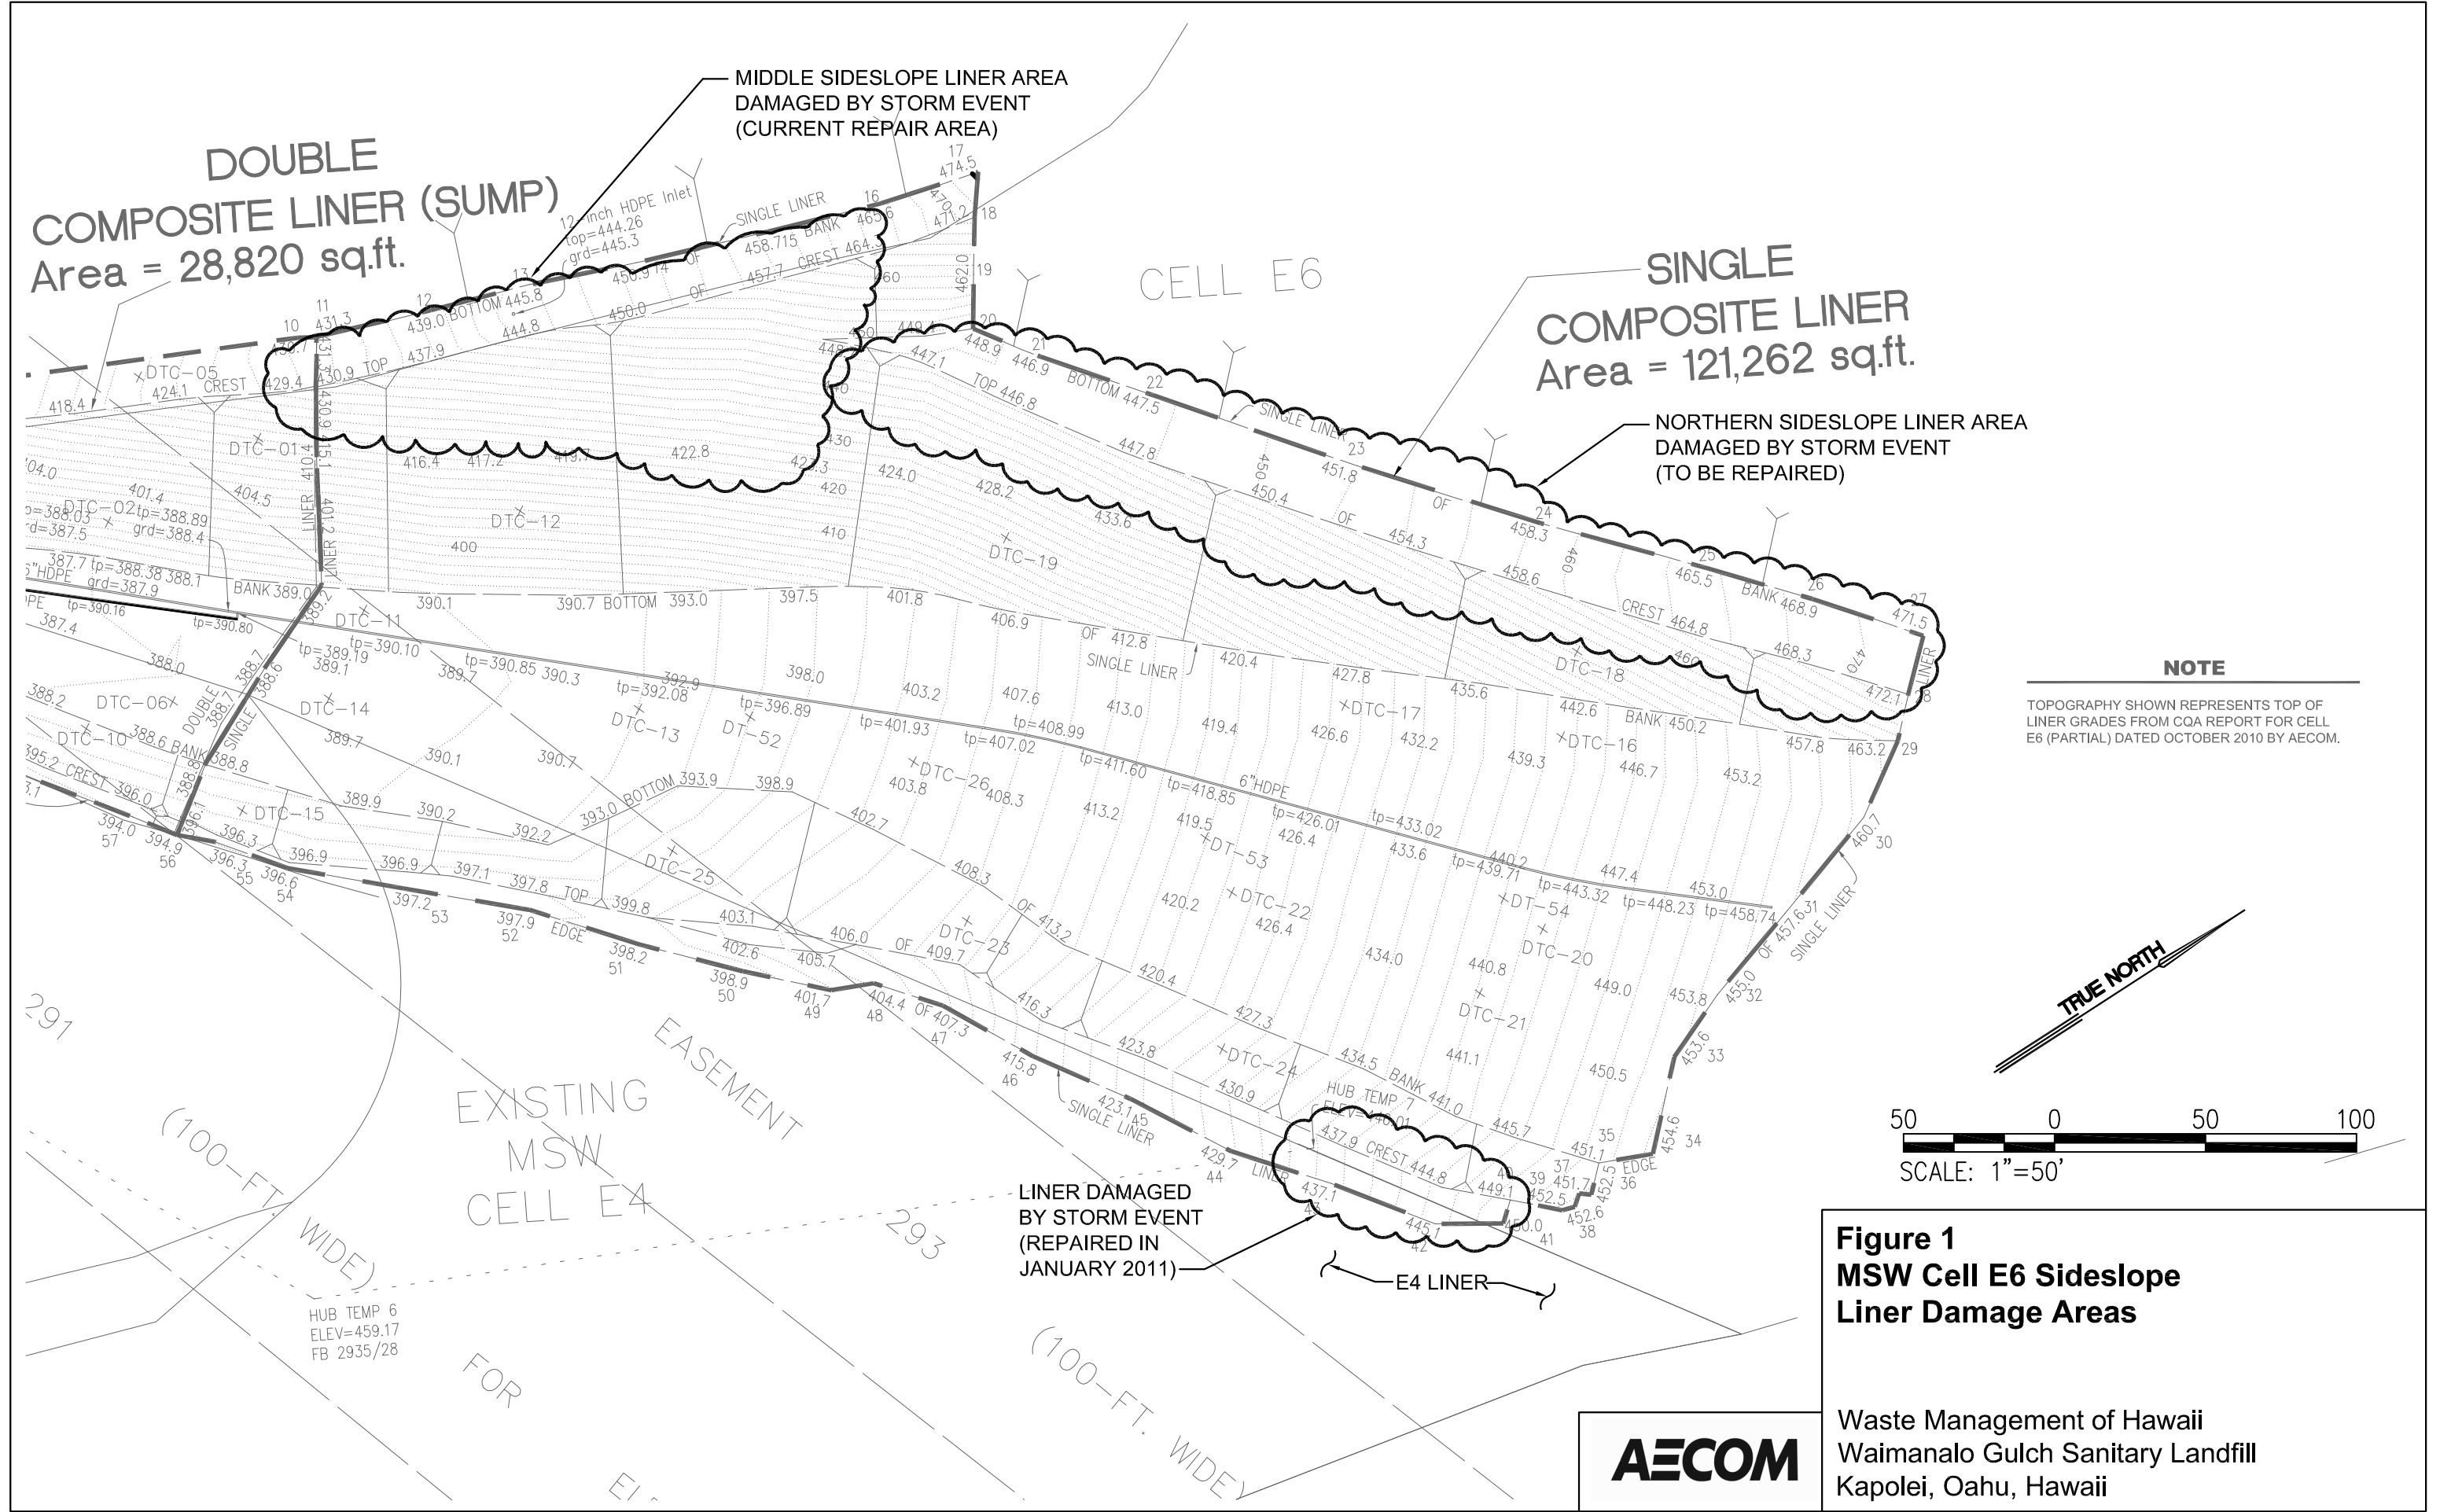
In late December 2010, a series of storms produced high run-on at the site resulting in damage to the northeastern edge of the MSW Cell E6 liner where it joins with Cell E4. Another large storm arrived on the evening of January 12, 2011 that resulted in additional flooding of the landfill and damaged the exposed portion of the western sideslope area of the MSW Cell E6 liner system. The damaged areas are shown on Figure 1, Attachment 1.

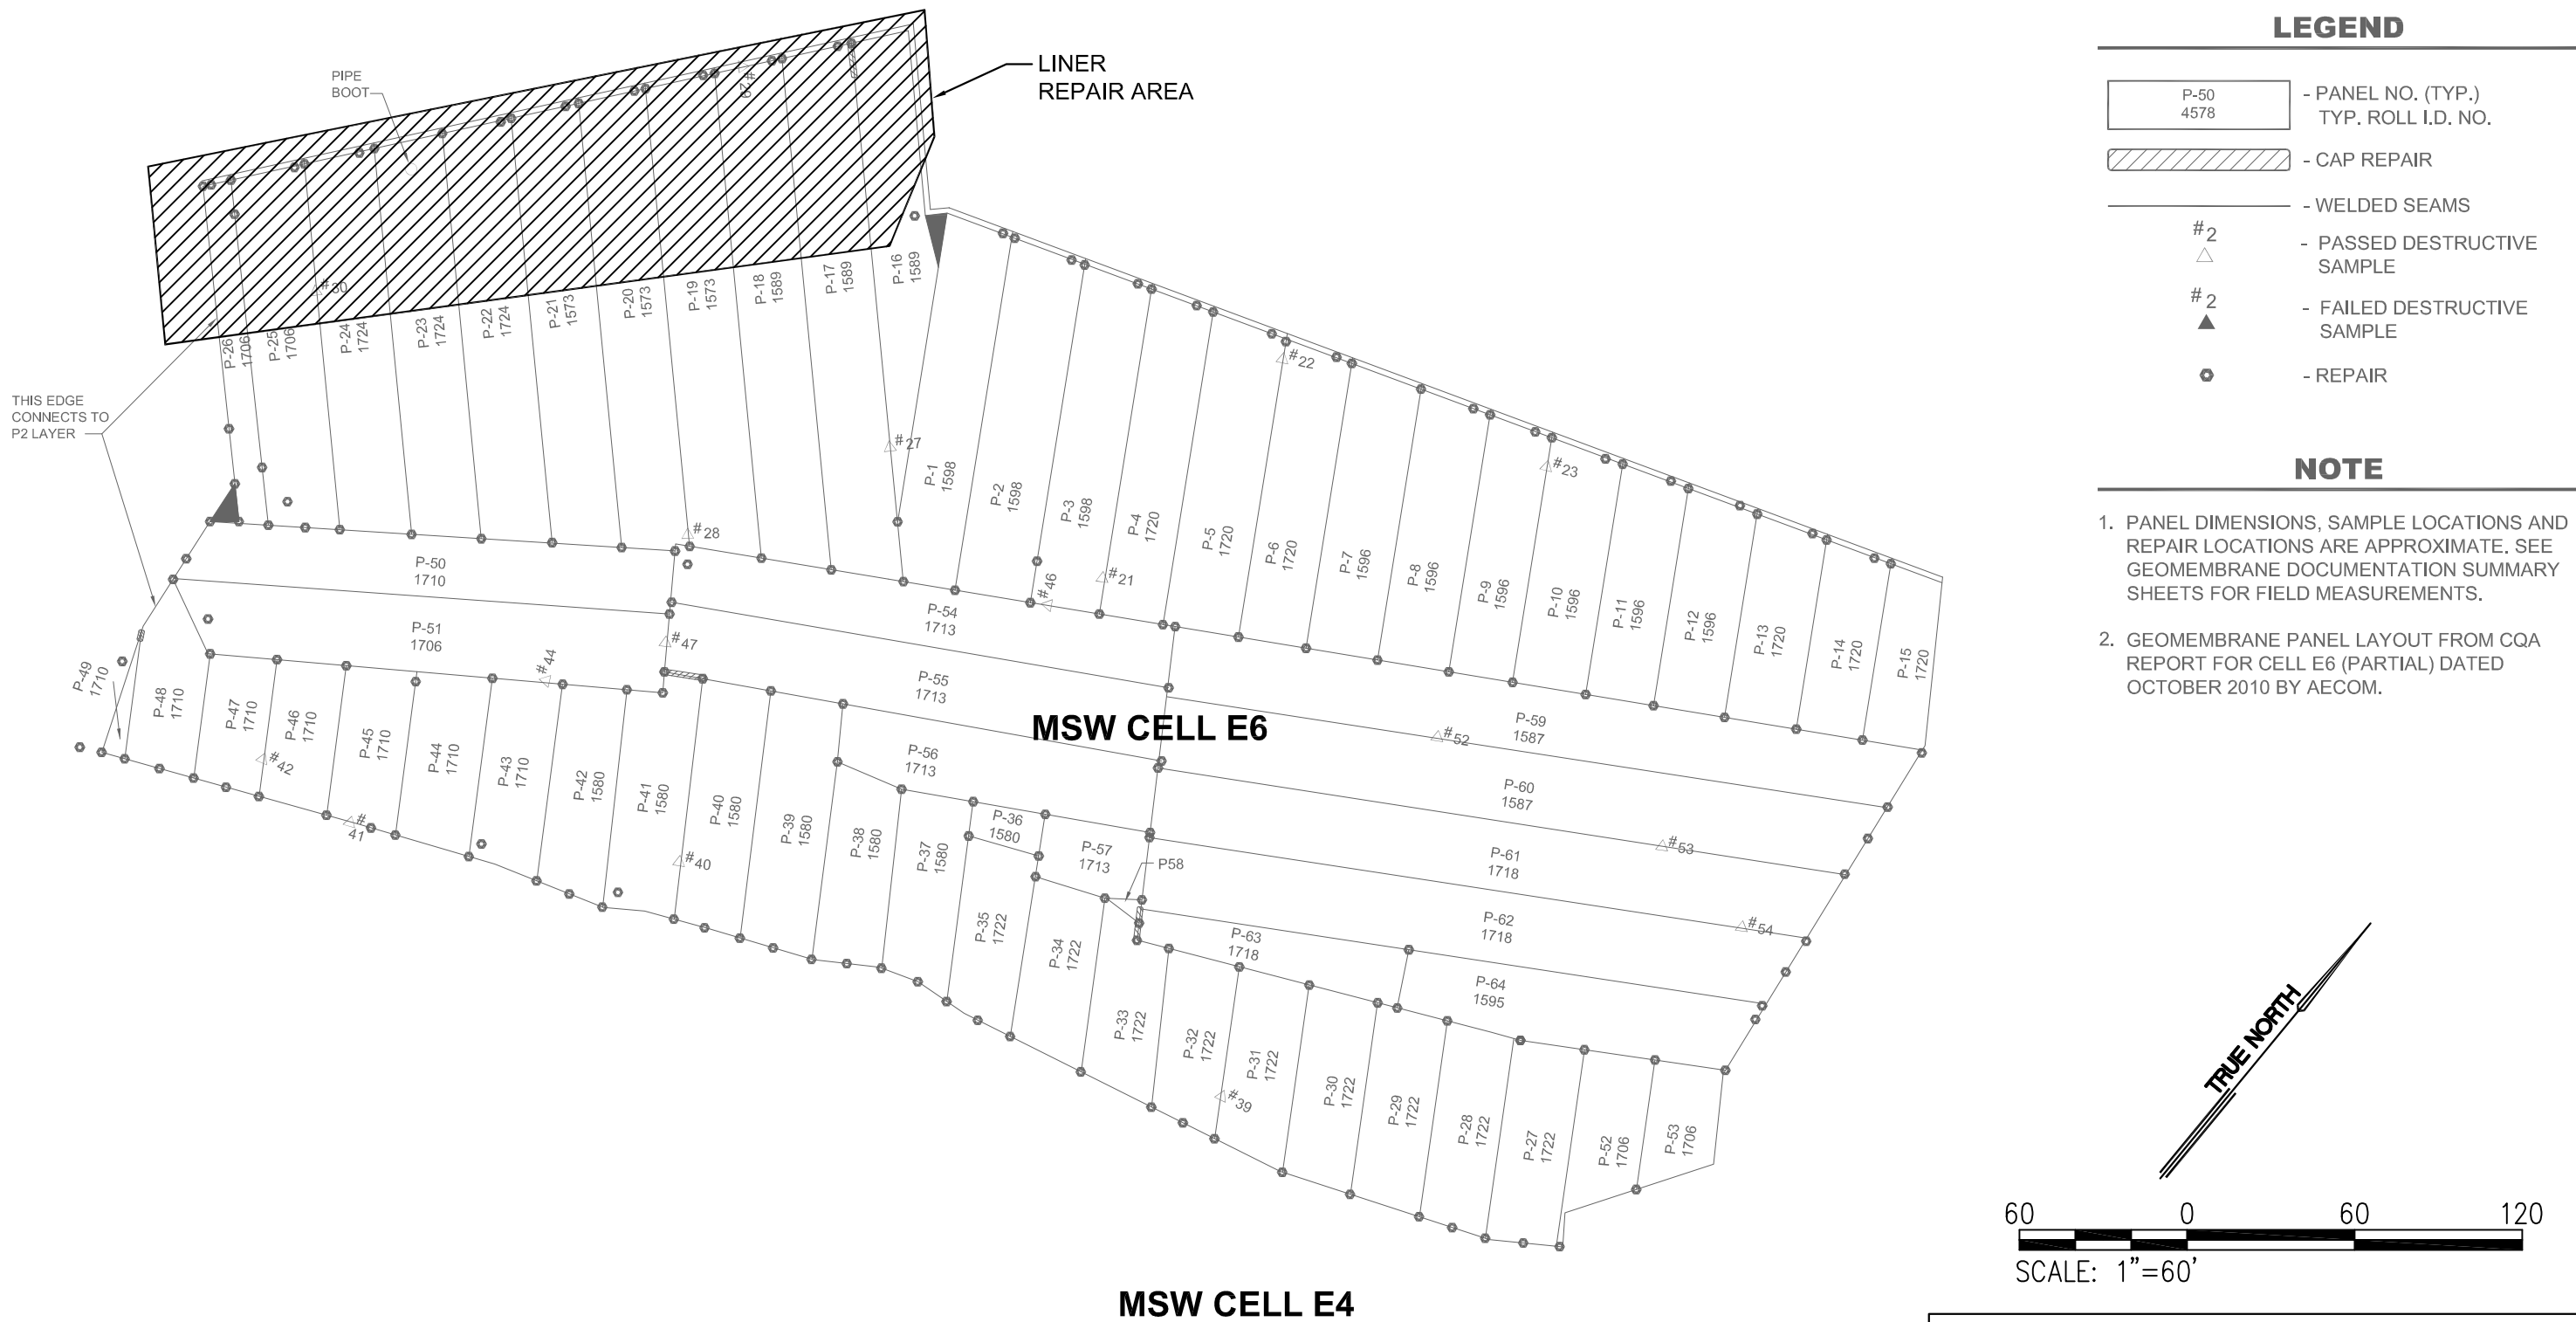
Figure 2
MSW Cell E6 Sideslope
Repair Area

Work began on February 3, 2011 to repair the wrinkles and expose the sections of the sideslope liner that contained hydrated GCL. Repairs were completed on February 17, 2011. An excavator and hand labor were used to carefully remove any MSW, operations layer, and sediment off of the liner system so it could be inspected. Inspection holes were cut through the multiple layers of the liner system to determine if the GCL had been hydrated and where sediment had been deposited. This uncovering process continued until all damaged areas were exposed in the middle area of the sideslope. No damage to the subgrade cushion soil was observed during the inspection. The area requiring repair is shown on Figure 2, Attachment 1.

The repair area and repair locations are shown on Figure 2 and Figure 3 in Attachment 1. The area is along the sideslope area of Cell E6, corresponding to originally installed panels P2-1 through P-16 (60-mil panel numbers), and is approximately 250-ft long in the north-south direction and 70-ft wide in the east-west direction. Repairs to the geomembrane were made at locations where the liner was physically damaged during the storm events, in addition to areas cut to remove wrinkles, sediment, or hydrated GCL.

Once the damaged liner area was fully delineated, repairs were conducted to remove any wrinkles, hydrated GCL, and trapped sediment between the liner system layers. Following removal of damaged liner material, the liner system components were replaced with new material. Details of the repair activities and CQA observations are presented in Section 3.0. Areas to the north and south of the repair area will be uncovered later in 2011 when rockfall hazards/sediment are removed and these conclusions can be verified.

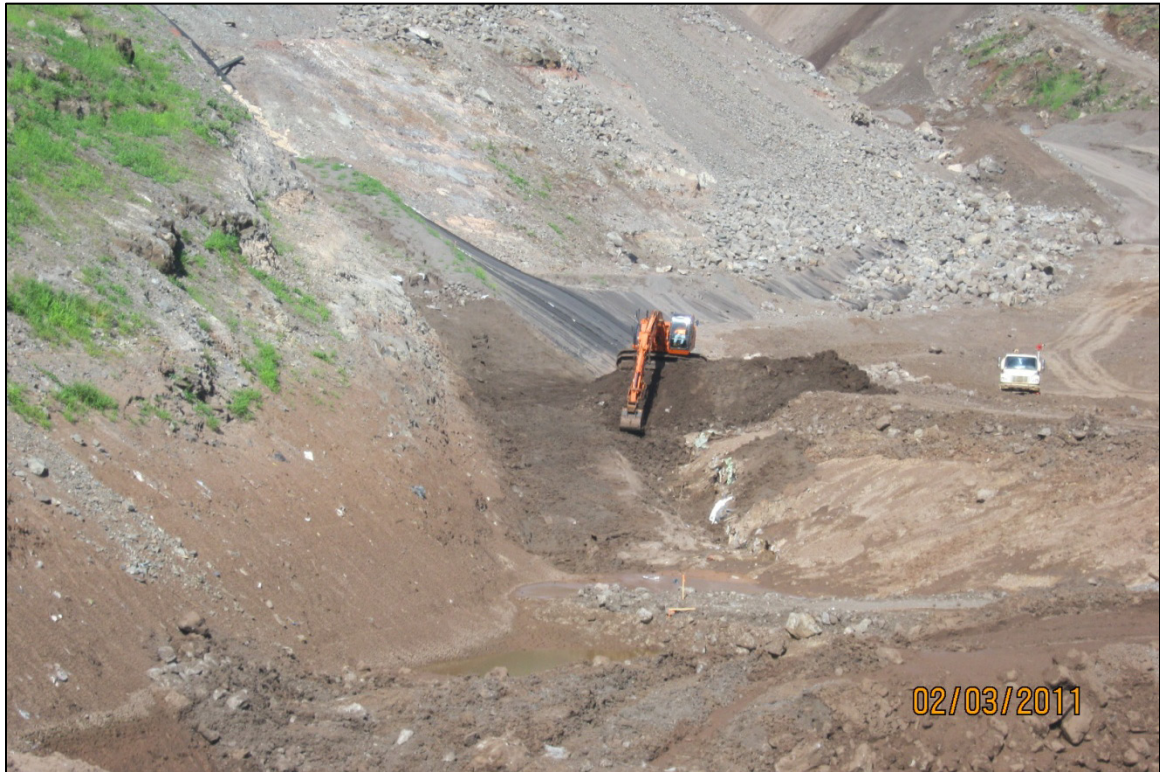
Photo 1: Excavator removing sediment along sideslope to expose wrinkles in liner north of the sump.

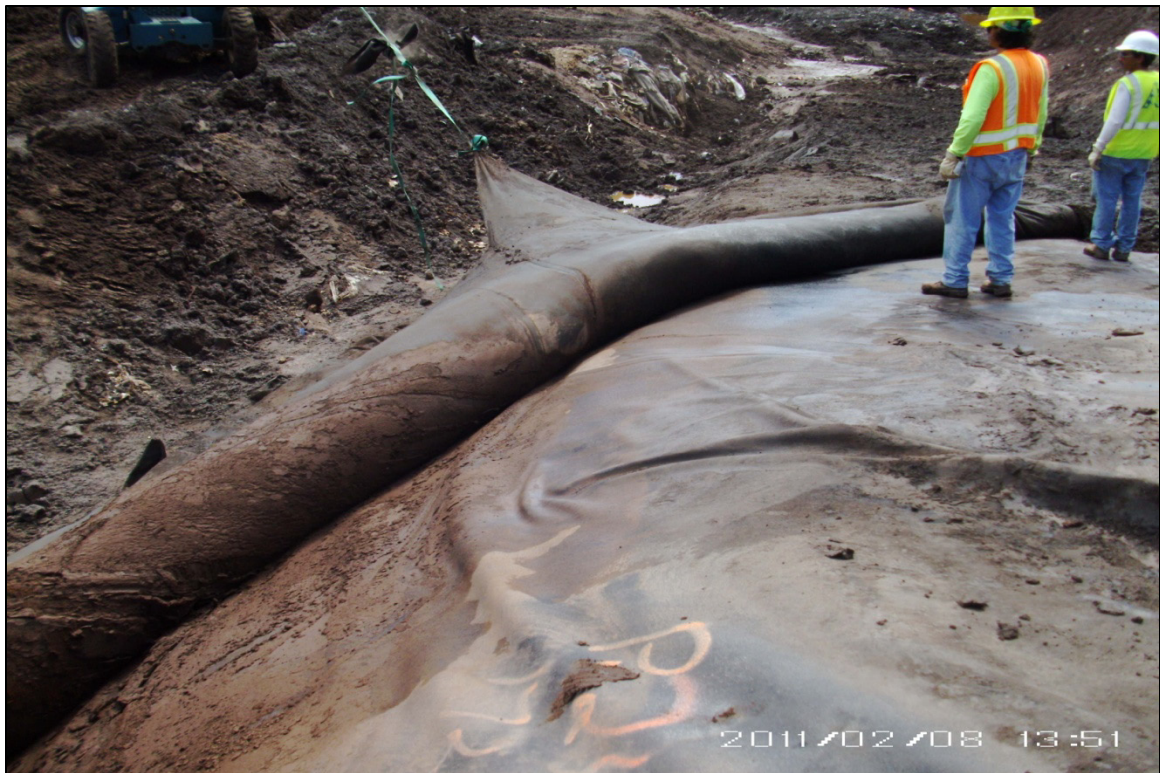
Photo 2: Removing 16-oz/yd² geotextile/sediment to expose wrinkles in 60-mil geomembrane.

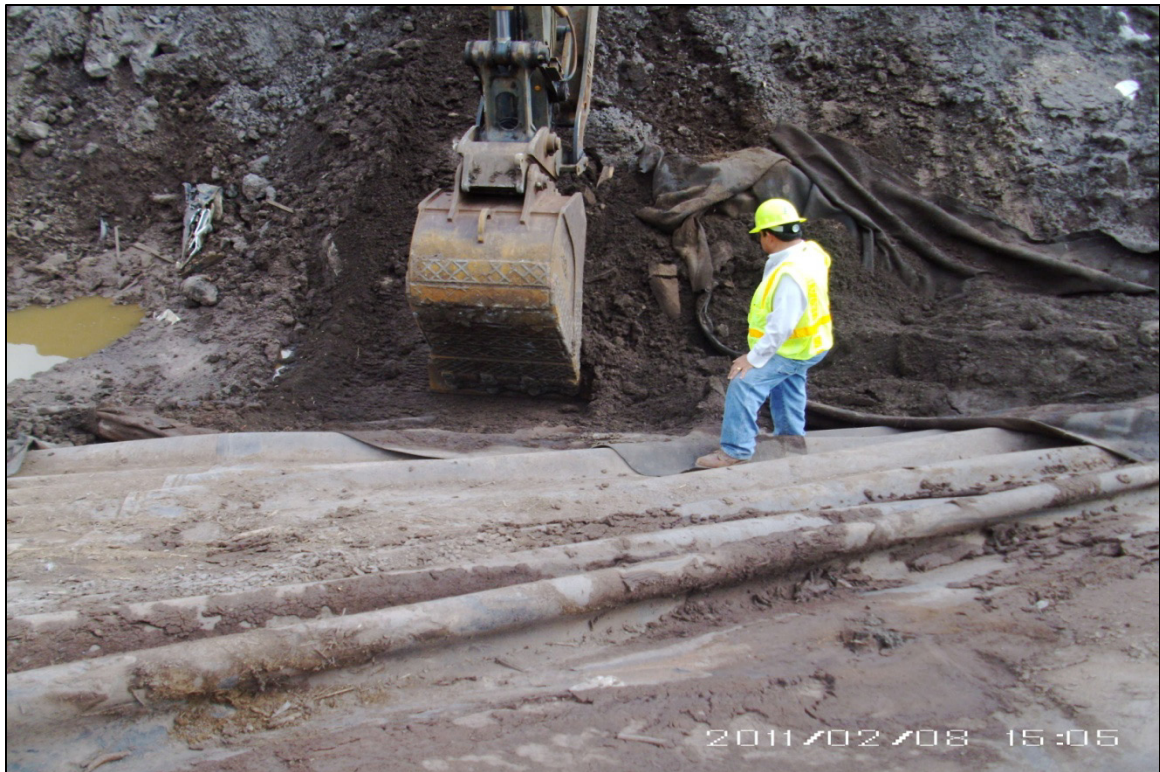
Photo 3: Excavator removing sediment at toe of MSW slope to expose wrinkles in 60-mil geomembrane.

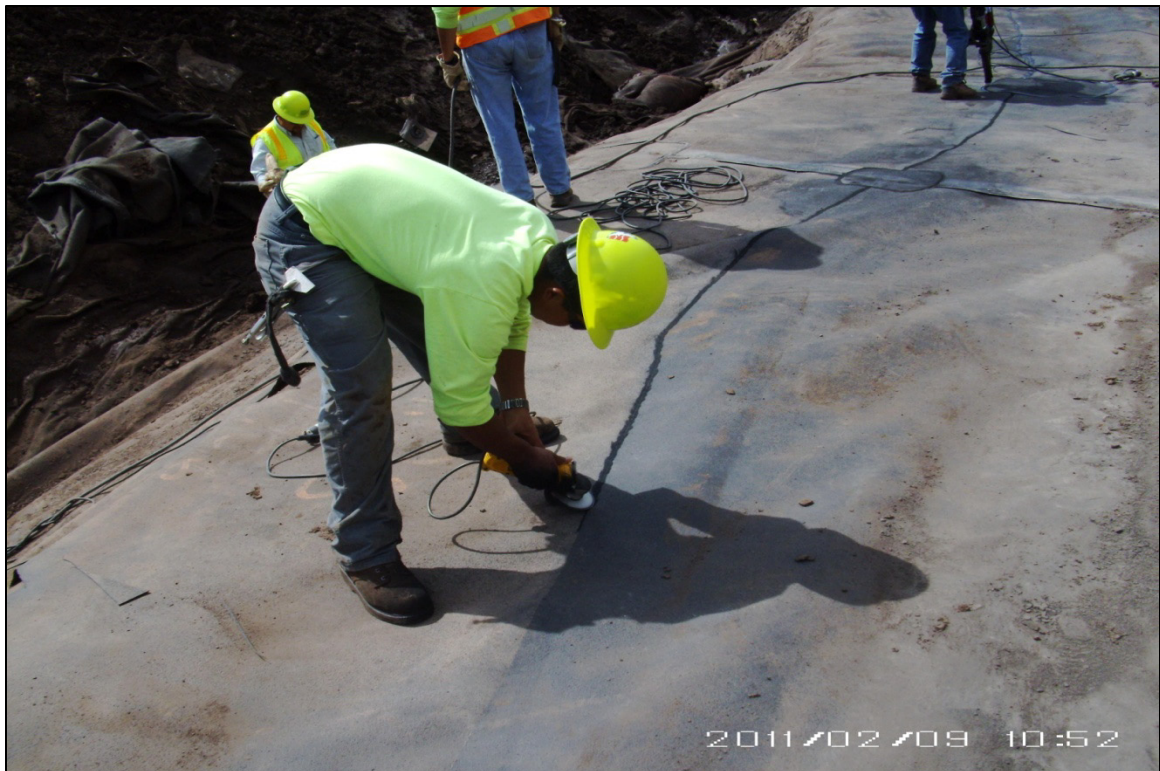
Photo 4: Preparing seam for extrusion weld with a grinder following removal of the wrinkle in 60-mil geomembrane.

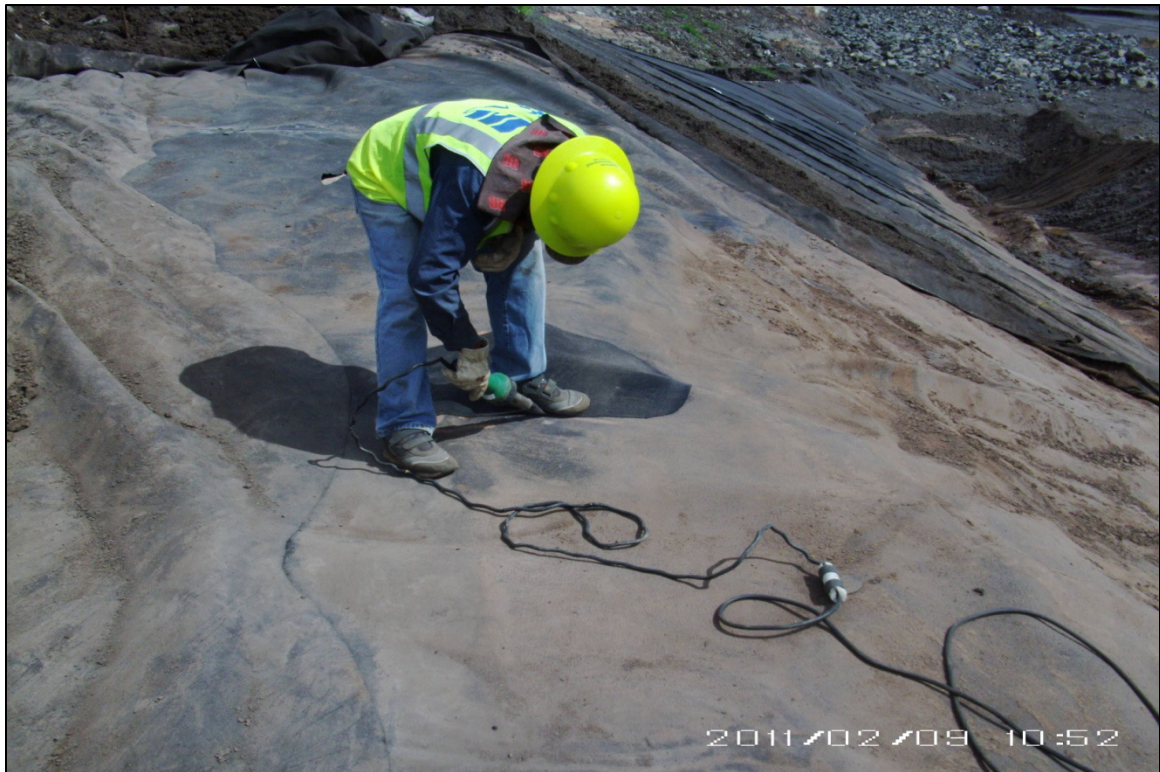
Photo 5: Heat tacking a repair patch on the 60-mil geomembrane.

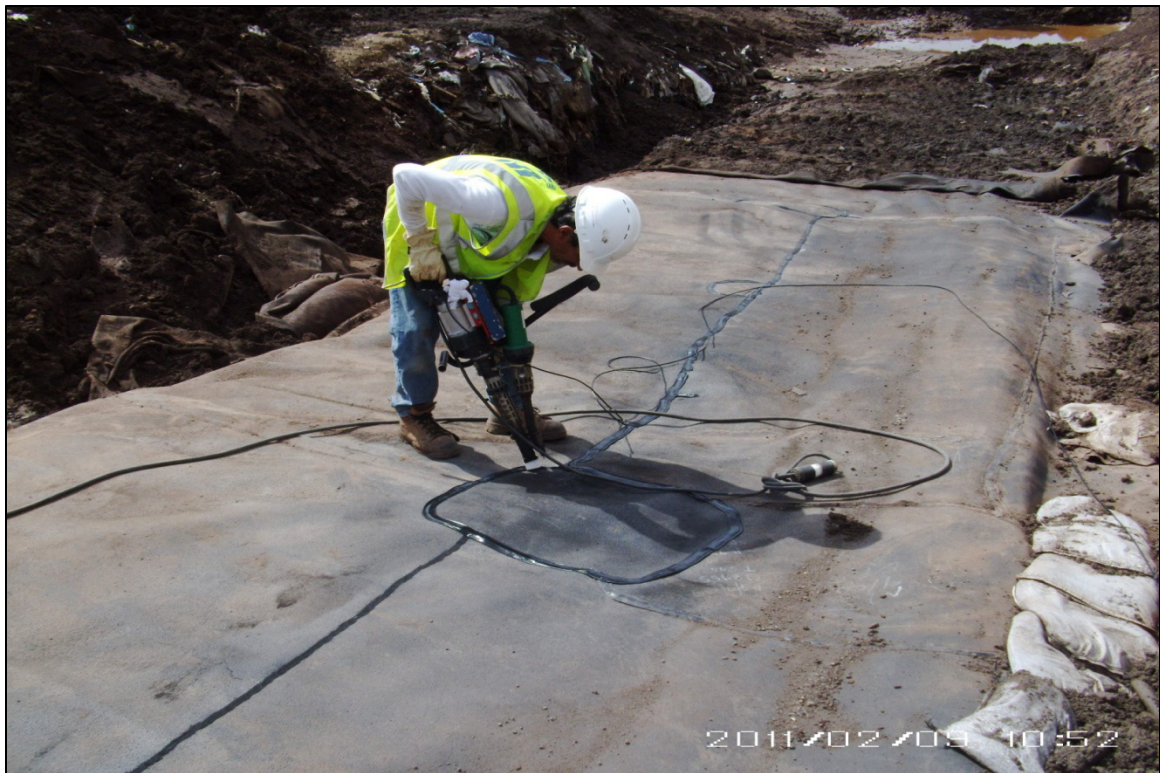
Photo 6: Extrusion welding of 60-mil geomembrane following repairs to remove wrinkles.

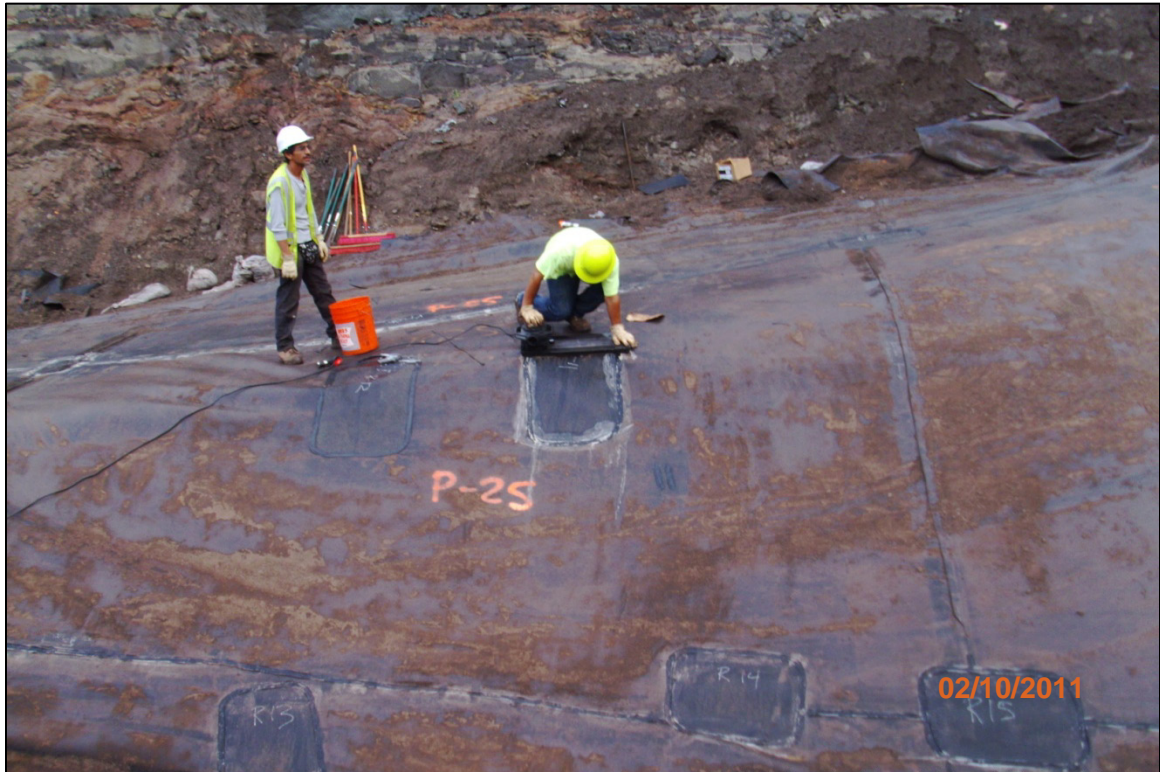
Photo 7: Non-destructive testing of a repair with vacuum box.

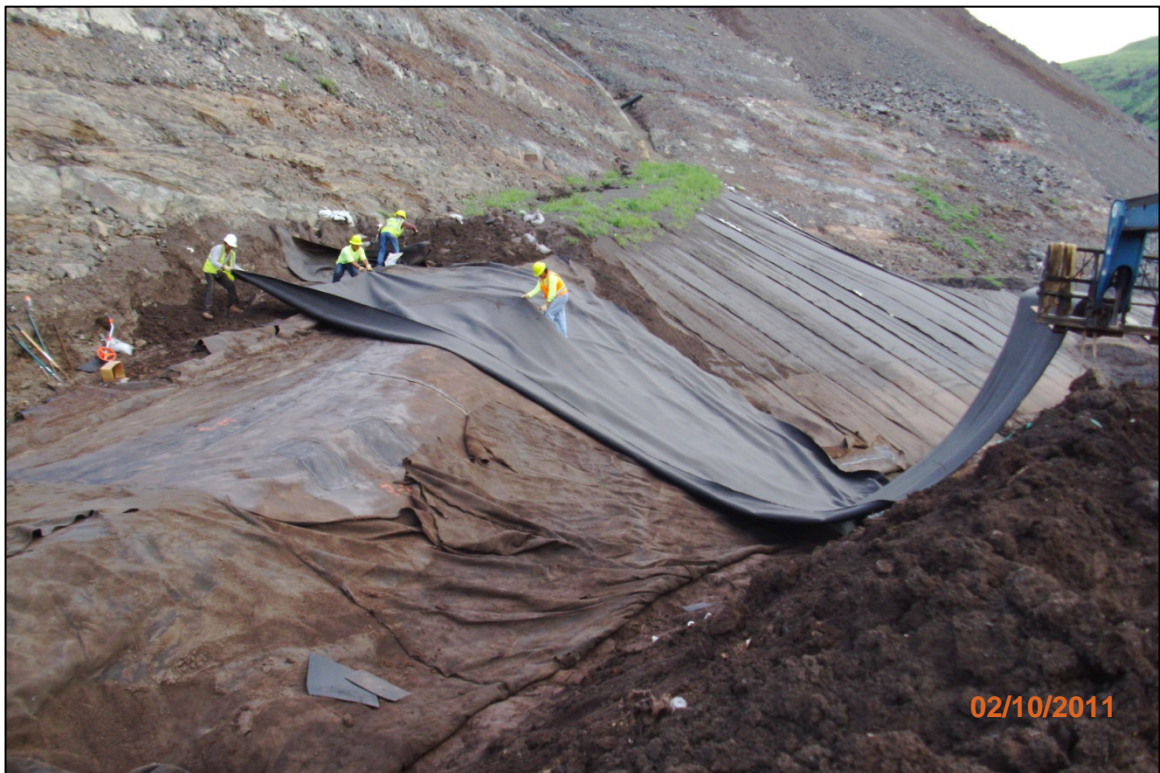
Photo 8: Deploying 16-oz/yd² geotextile following repairs to remove wrinkles.

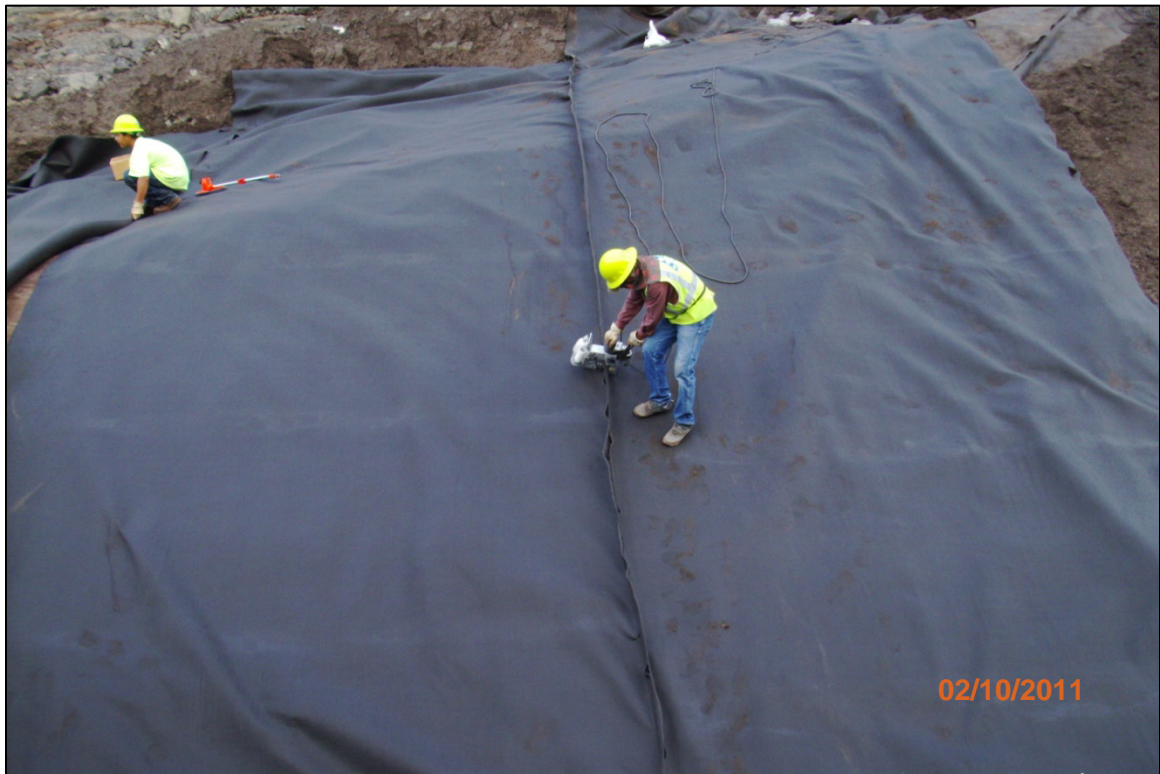
Photo 9: Sewing 16-oz/yd² geotextile following deployment.

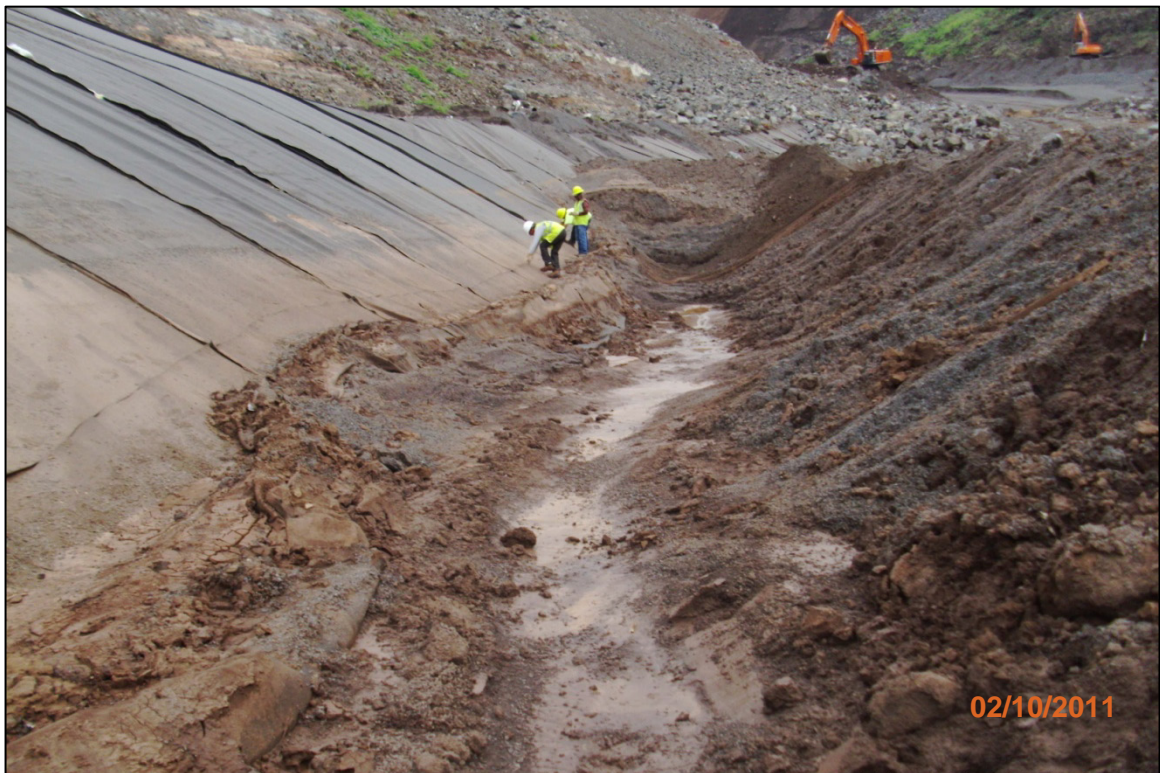
Photo 10: Exposing area with sediment under 16-oz/yd² geotextile and 60-mil geomembrane, looking north along the sideslope towards.

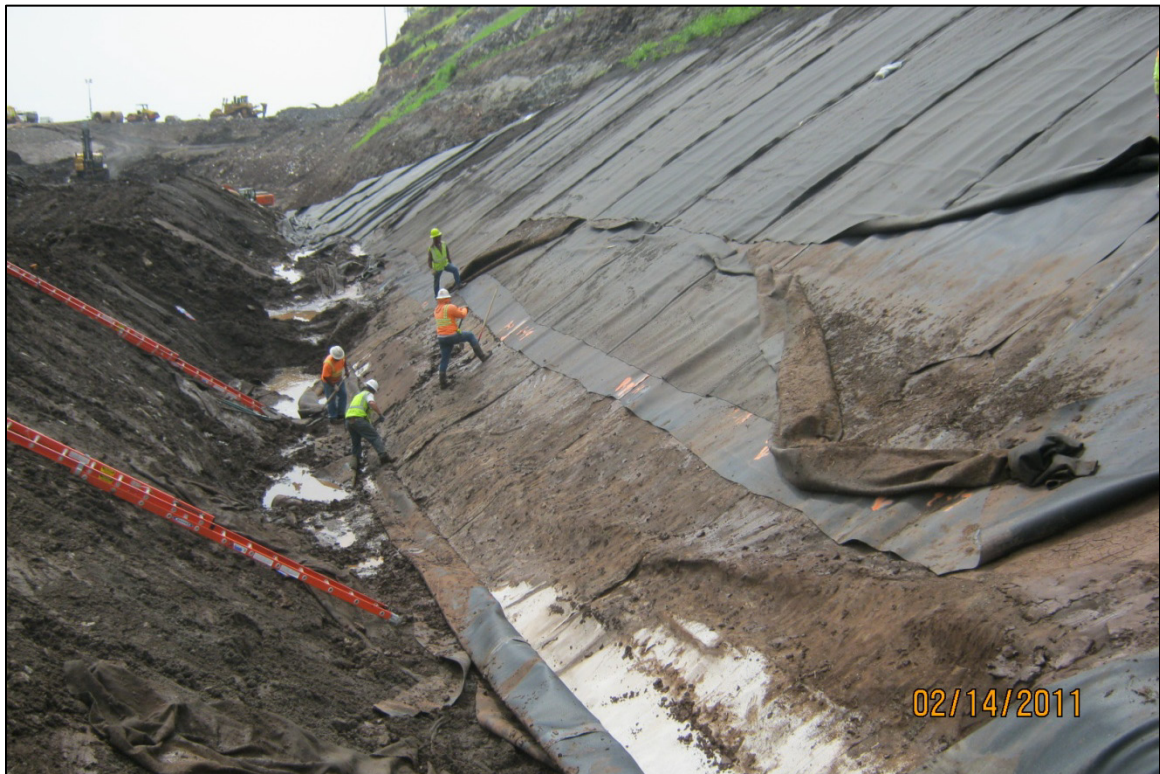
Photo 11: Removing sediment from between the 60-mil geomembrane and GCL along the sideslope.

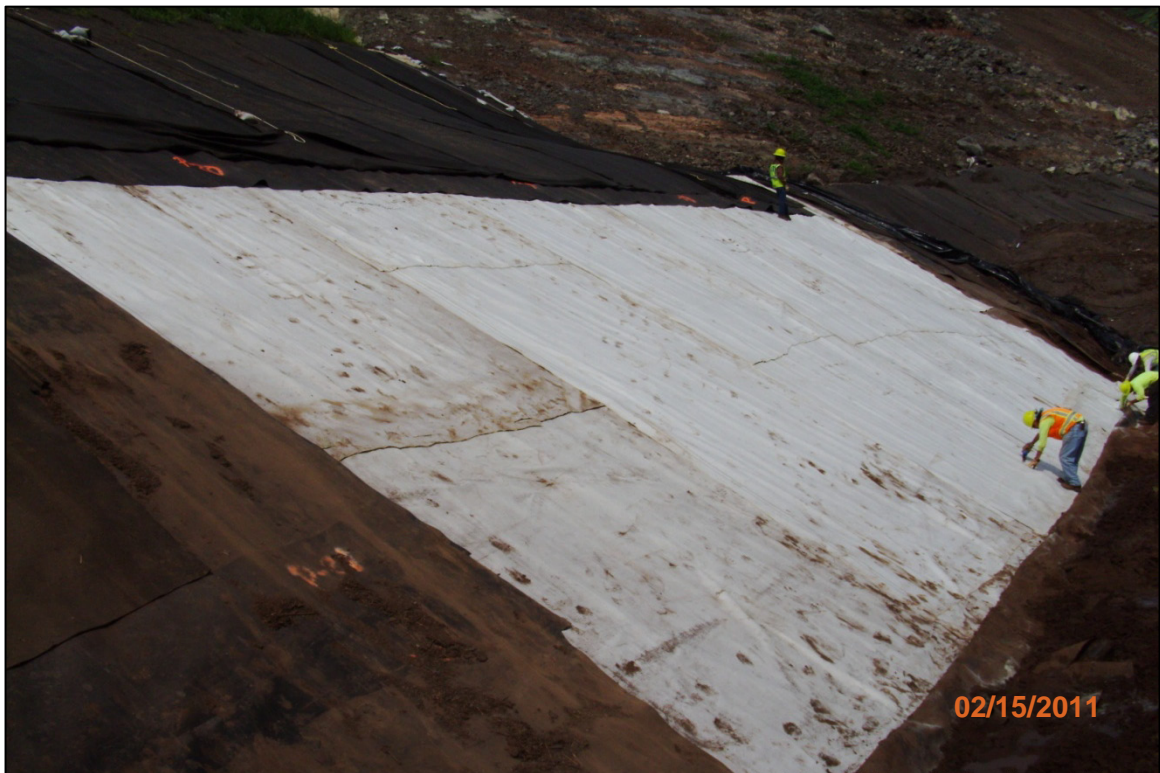
Photo 12: New GCL material following removal of hydrated GCL and sediment, looking north.

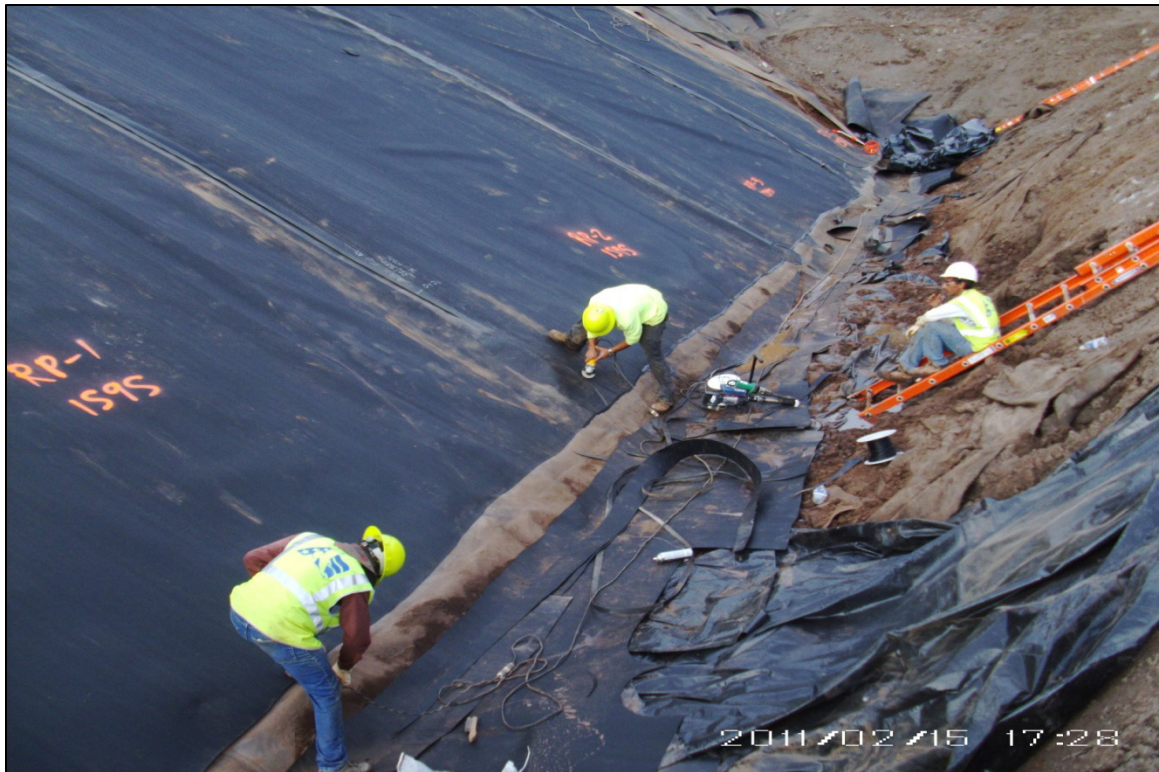
Photo 13: Preparing tie-in to existing 60-mil geomembrane following removal of sediment/hydrated GCL and deployment of new geomembrane.

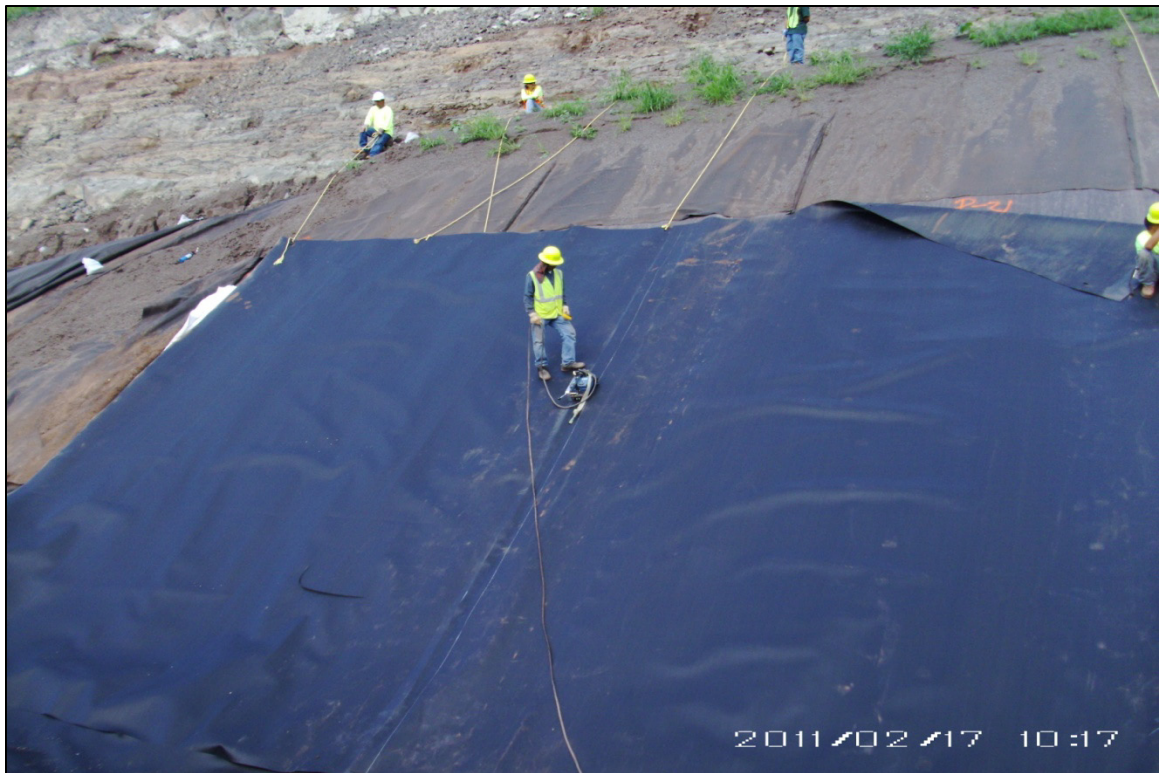
Photo 14: Fusion welding repair panels of 60-mil geomembrane following removal of sediment and hydrated GCL.

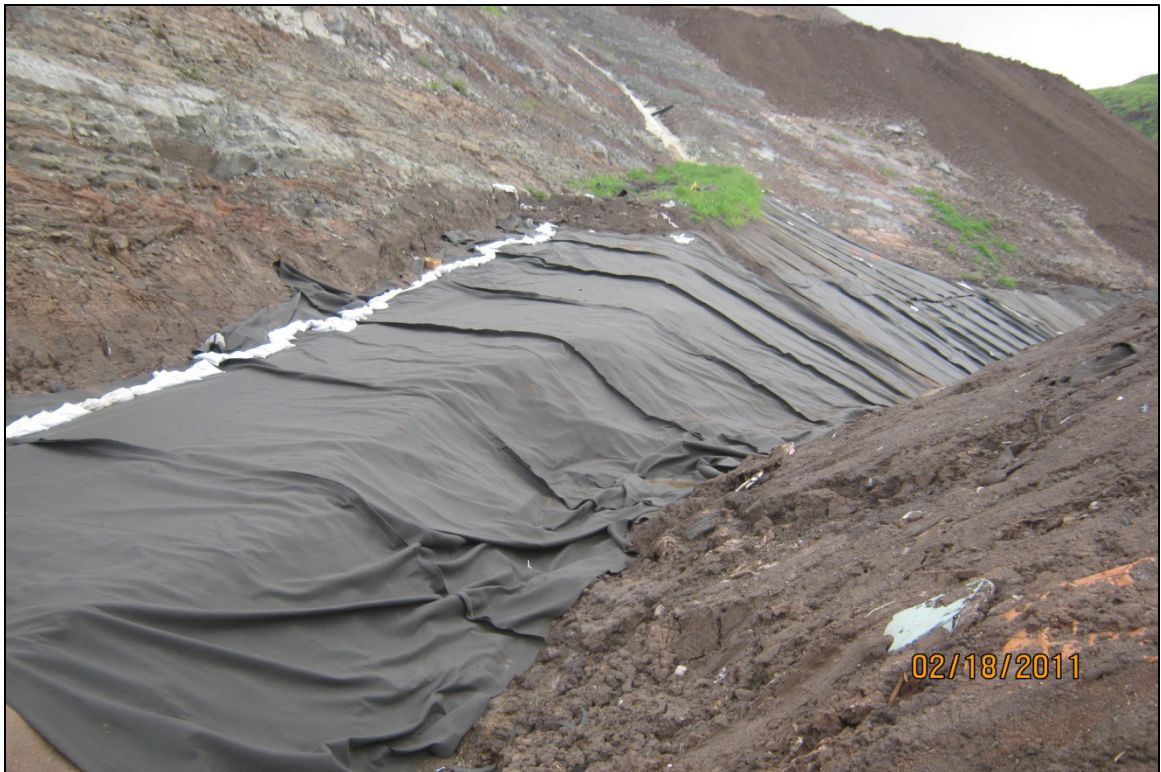
Photo 15: Overview of the southern portion of the repair area following removal of wrinkles and damaged liner system components, looking north.

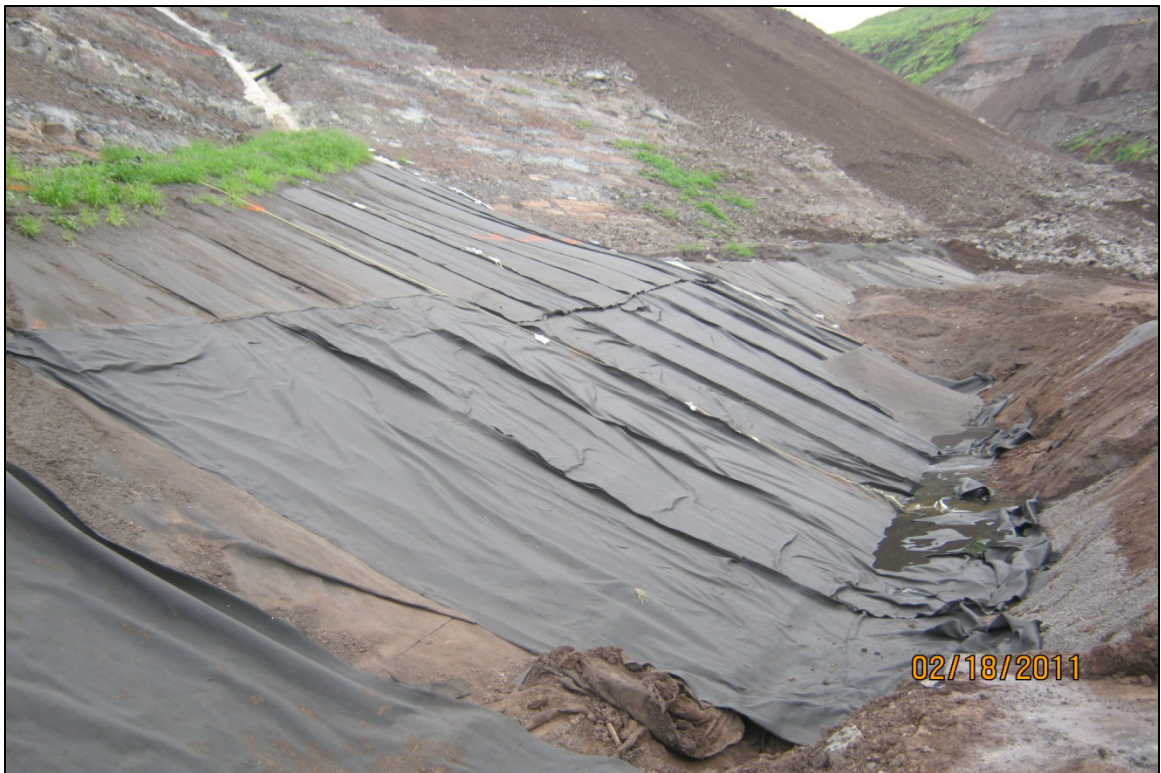
Photo16: Overview of the northern portion of the repair area following removal of sediment and hydrated GCL.
